DRIVE SHAFT BOLTS - SEMI TRAILING AXLE

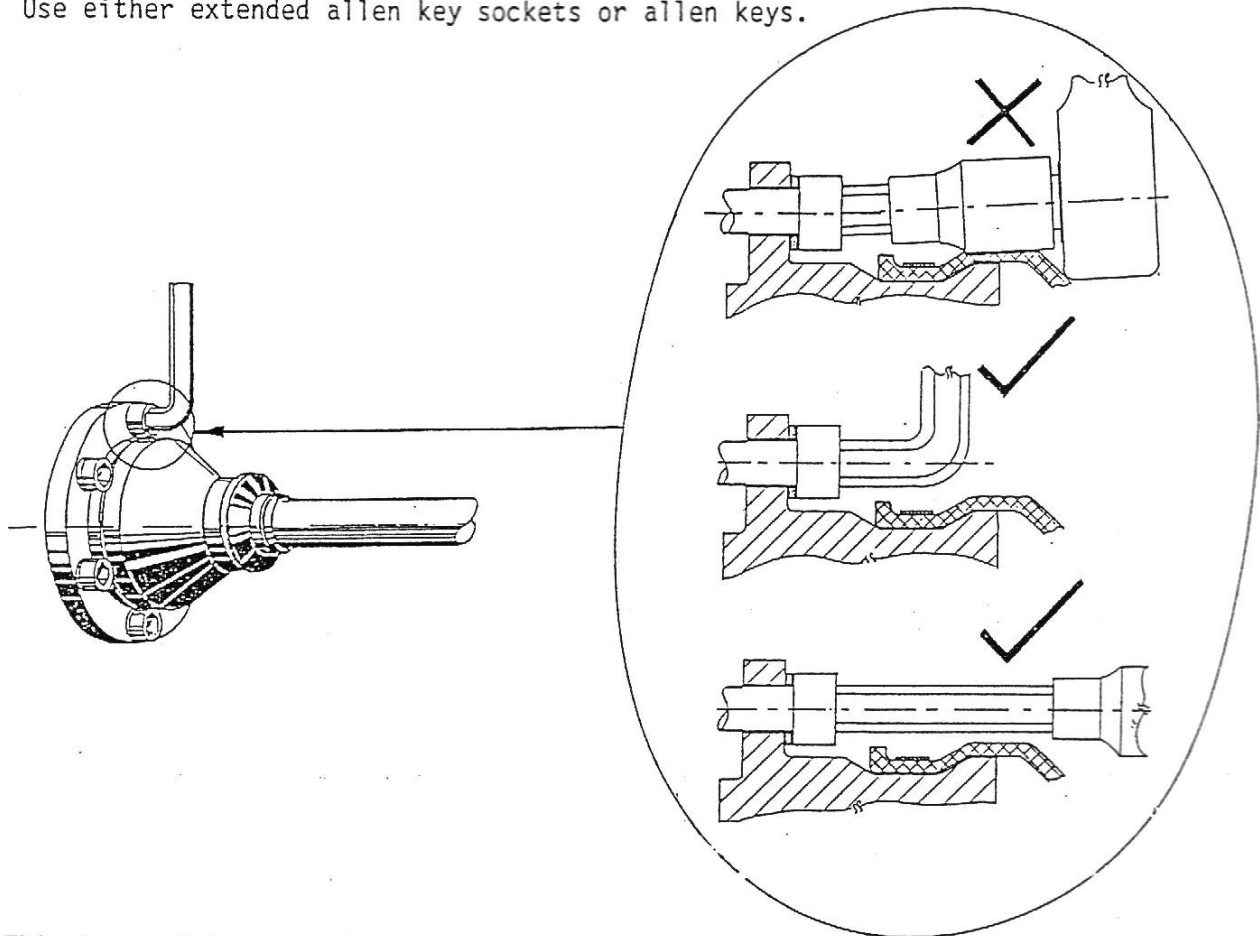
We draw your attention to the possibility of damage to the gaiter of the outer constant velocity joint being caused by the use of inappropriate tools. This damage results in the loss of lubricant and subsequent damage to the drive shaft joint.

The use of short allen key sockets to tighten or remove the allen bolts results in the gaiter being punctured by being trapped between the socket and joint.

Use either extended allen key sockets or allen keys.
